# PROGRESS REPORT

Determination of Engine Condition

Spectrographic Analysis of Engine

Jack F Witten Bureau of Naval Weapons

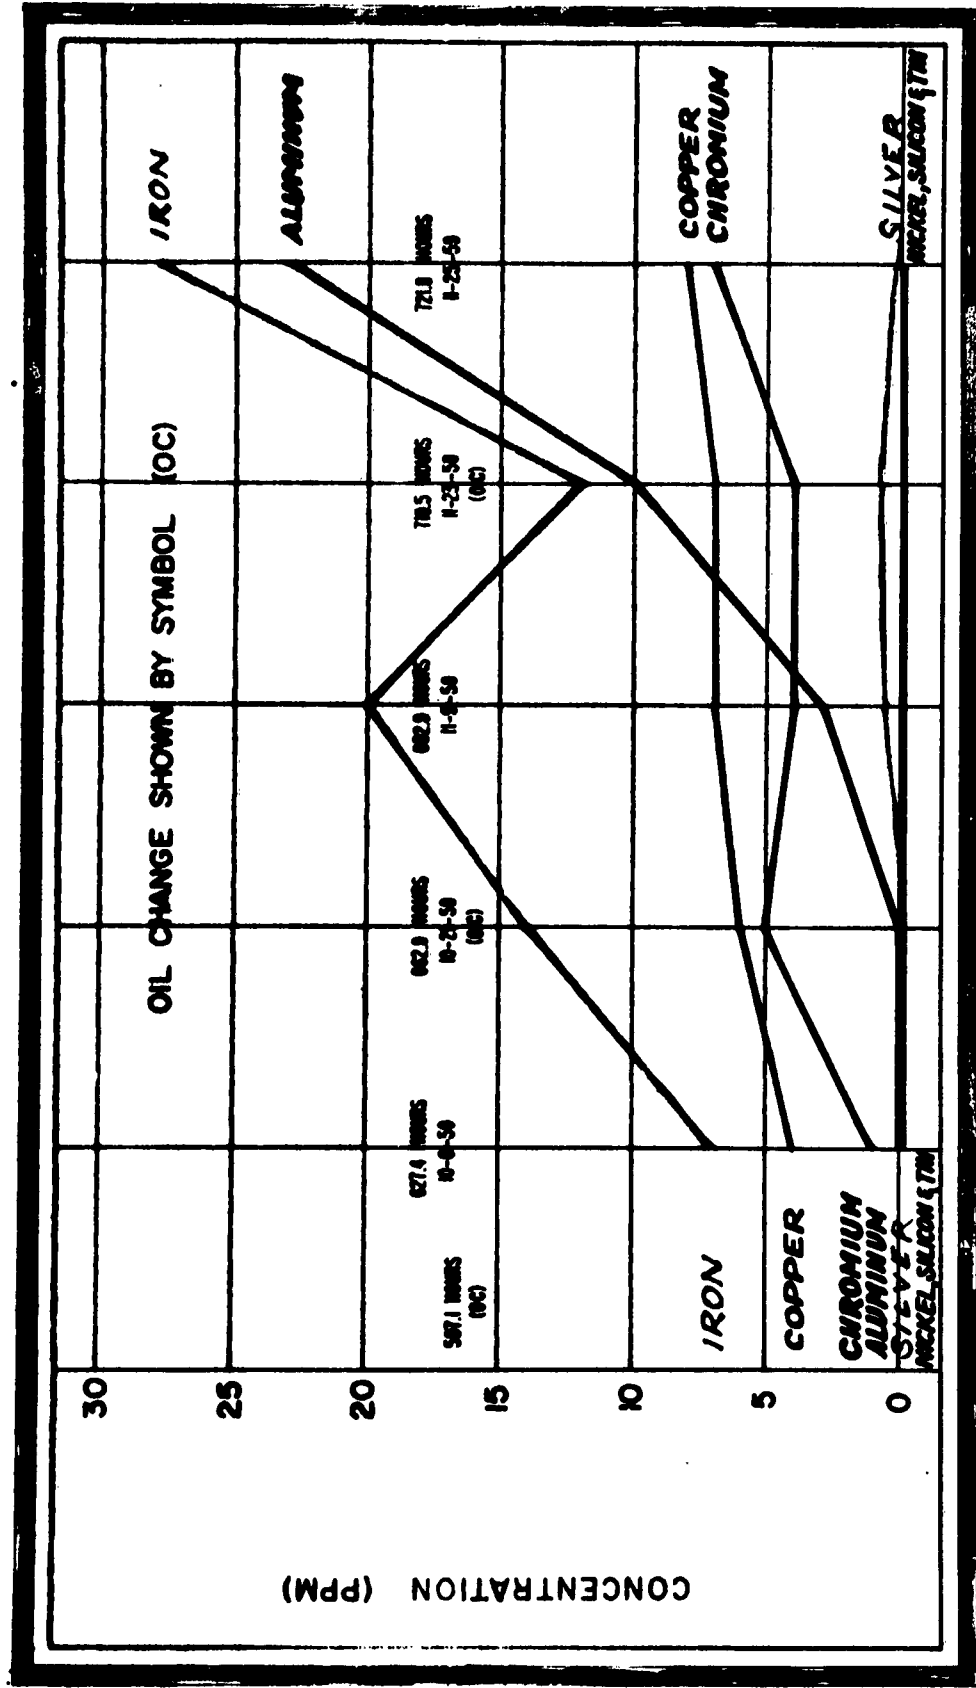
**R-1820-86 ENGINE**      **BU NO 138108**

The history of this engine is shown graphically on this chart. The threshold limits we are using for the R-1820 engines in PPM are 35 iron, 10 chromium, 8 aluminum, 4 PPM silver. This engine has exceeded the aluminum threshold limits. Traces of silver have also been detected. A check sample is requested by dispatch. The check sample indicates aluminum levels have doubled since the last sample, iron is approaching the threshold limit and copper and chromium are increasing.

# **CHART SHOWING ALL ANALYSES OF OIL SAMPLES** **TAKEN FROM ONE AIRCRAFT ENGINE UP TO TIME OF FAILURE**

The squadron is notified and engine removal is recommended.

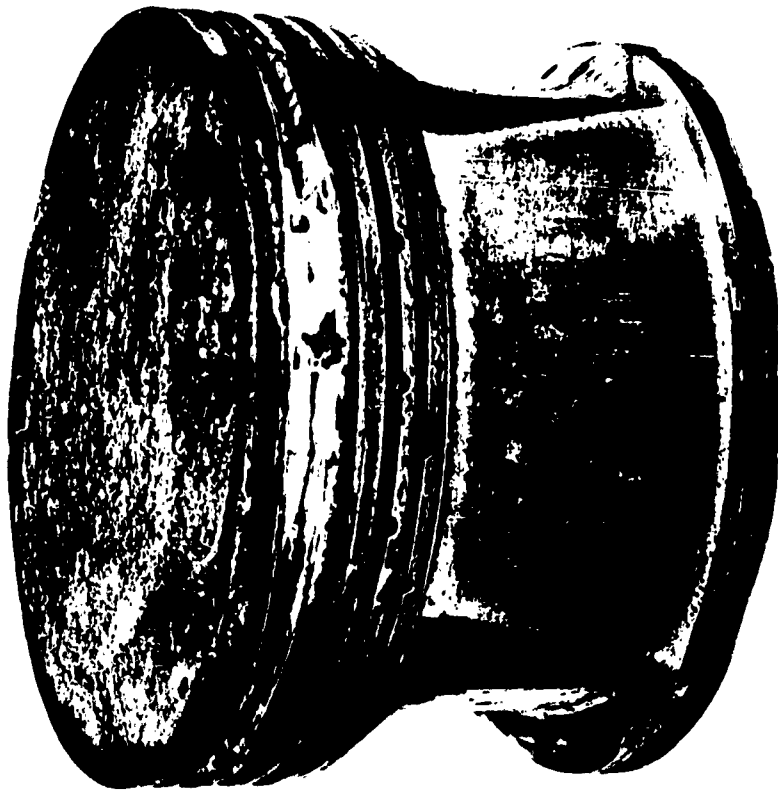
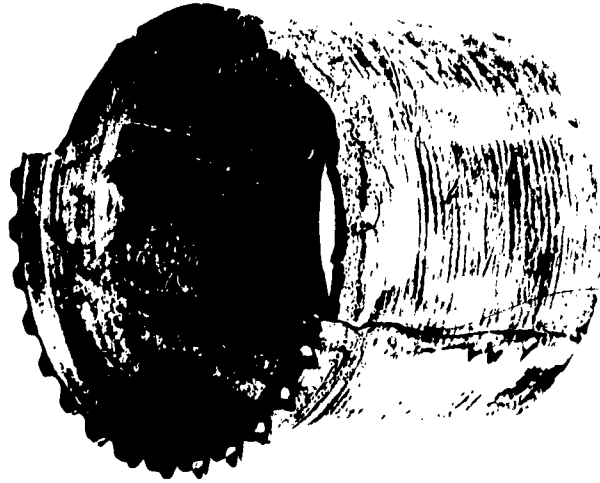
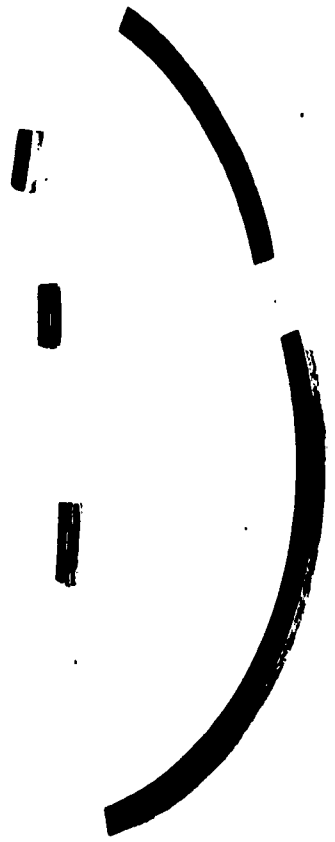
This is the way the piston and the master rod bearing looked upon disassembly.

1. Number 6 piston, P/N 136685, top piston ring groove excessively worn and installed piston ring, P/N 139619, worn on the tapered faces and broken.
2. Master connecting rod bearing, P/N 133641, fractured across fourteen locking splines. The bearing also contained one crack running the length of the bearing.

1. The cause of excessive wear between the top piston ring and piston ring groove is presently under investigation.
2. The result of fatigue cracks originating at the roots of one or more locking splines.
